Fire Research Group
Department of Mechanical and Mechatronics Engineering
University of Waterloo
Waterloo ON Canada N2L 3G1
E. Weckman, A. Topic, T. Sheehan and G.Hitchman

MARITIME EVALUATION OF AEROSOL FIRE KNOCK DOWN TOOLS

PART 2: TOXICITY AND CORROSION POTENTIAL

DRDC DOCUMENT NUMBER: DRDC-RDDC-2014-C32

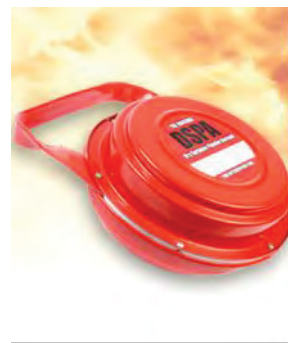
a) StatX First Responder®

The aerosol units tested were the StatX First Responder® with a single unit rated for use in fire compartments of no more than 20 m³ and the DSPA 5-4 Manual Firefighter® with a single unit rated for use in fire compartments of no more than 18 m³. These are shown in Figure 1-1 a) and 1-1 b) respectively.

Figure 1-1: StatX and DSPA 5-4 extinguishing units used in testing

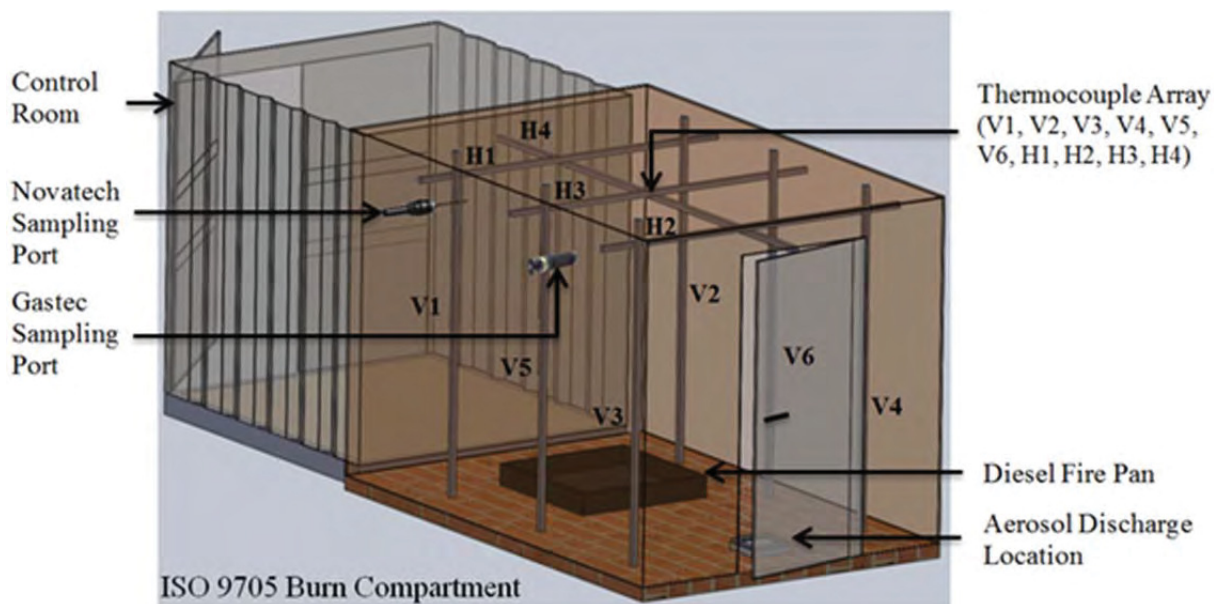
Figure 3-1: UW shipping container burn room configured for diesel suppression in the machinery space

As shown in Figure 3-1, the UW shipping container facility is comprised of two sections, the burn room and the control room. The control room holds all of the electrical equipment to support testing, including the field point data logger used for data acquisition and electrical cabling used for powering the instrumentation. The burn room measures 2.4m wide x 3.6m long x 2.4m tall, for a total volume of 20.74 m³. At one end is a door measuring 0.91m wide x 1.75m tall which provides ventilation to the compartment. The compartment walls and ceiling are made of 2mm

thick Corten steel, insulated with a 25.4mm layer of Fibrefrax Durablanket insulation and clad with 1.25mm (18 gauge) aluminum sheeting. The floor is finished with fire brick [35].

Gas samples were withdrawn from two gas sampling ports positioned approximately 2 m above the floor and 1 m apart on the same side of the burn compartment, as shown in Figure 3-1. The Novatech samples were withdrawn from the location closest to the back of the compartment via a 6m long heated PTFE coated line with an internal graphite filter that prevented particulates from entering the sampling cell. Samples for the Gastec unit were withdrawn via a hand pump from a port approximately 1 m away and closer to the door of the compartment (Figure 3-1). Both gas sampling ports were positioned high in the compartment for all of the fire characterization and aerosol fire suppression tests.

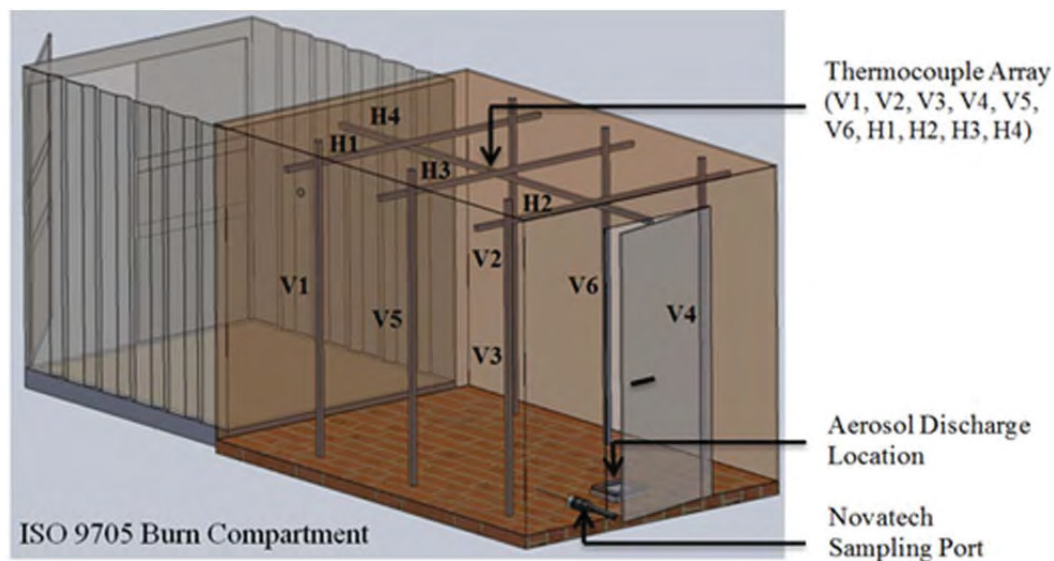
Figure 3-2: UW shipping container burn room configured for agent only test

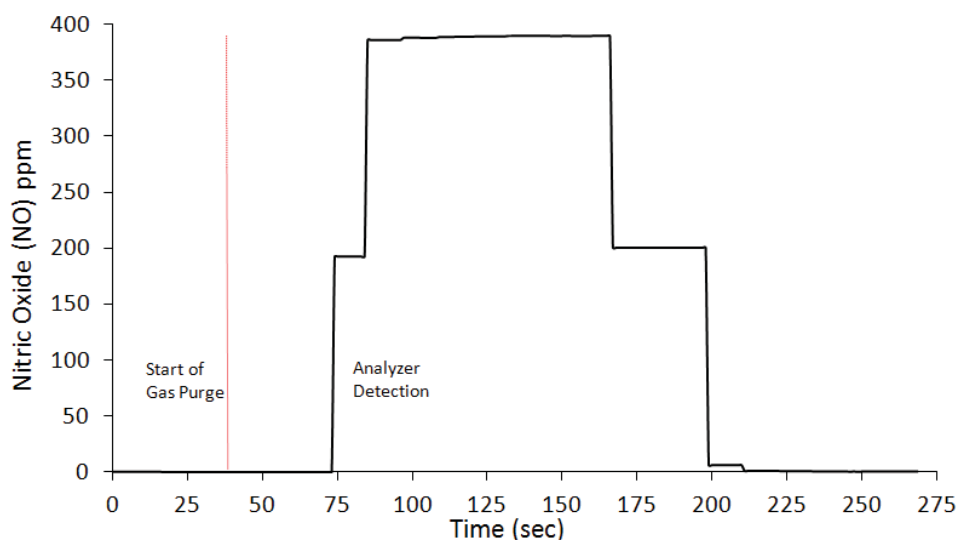
Figure 3-3- Determination of lag time for NO gas analysis system

There is an inherent time lag in response of the Novatech system to a change in concentration due to the length of sample lines used in the experiments and the inherent time response of each sensor in the unit. Since it is important to account for this delay in response during analysis and interpretation of measured gas concentrations, a test was undertaken to quantify the detection lag in the present results. A gas of known concentration of NO was injected at 1.8 L/min directly into the sampling line with no fiberglass filter present and the output from the detector was recorded by the data logger over time. Results are plotted in Figure 3-3 where the lag in response is clearly evident. Based on the data, the combined lag due to length of the sampling line, sampling flow rate and the purge and response time for the detector cell was approximately 38 seconds. This lag time is strongly influenced by the presence and condition of the filters in the sampling line; as far as possible, any time lag in system response is taken into account and the time axes for the data have been appropriately corrected to better facilitate interpretation of the results in the following sections.

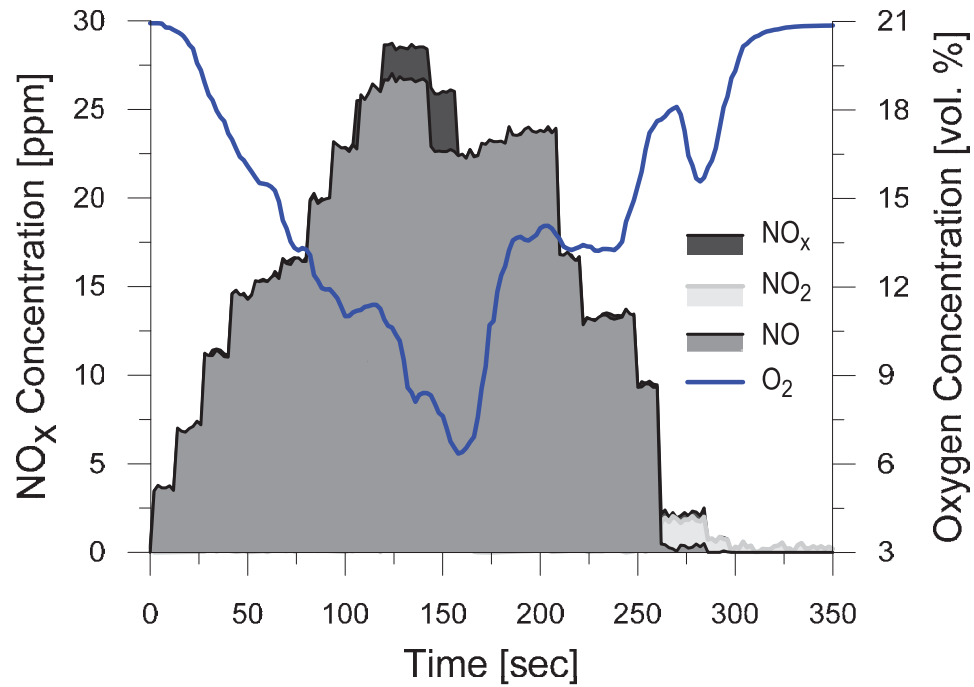
Figure 4-1: NO_x concentrations during a diesel fire characterization burn with door fully open

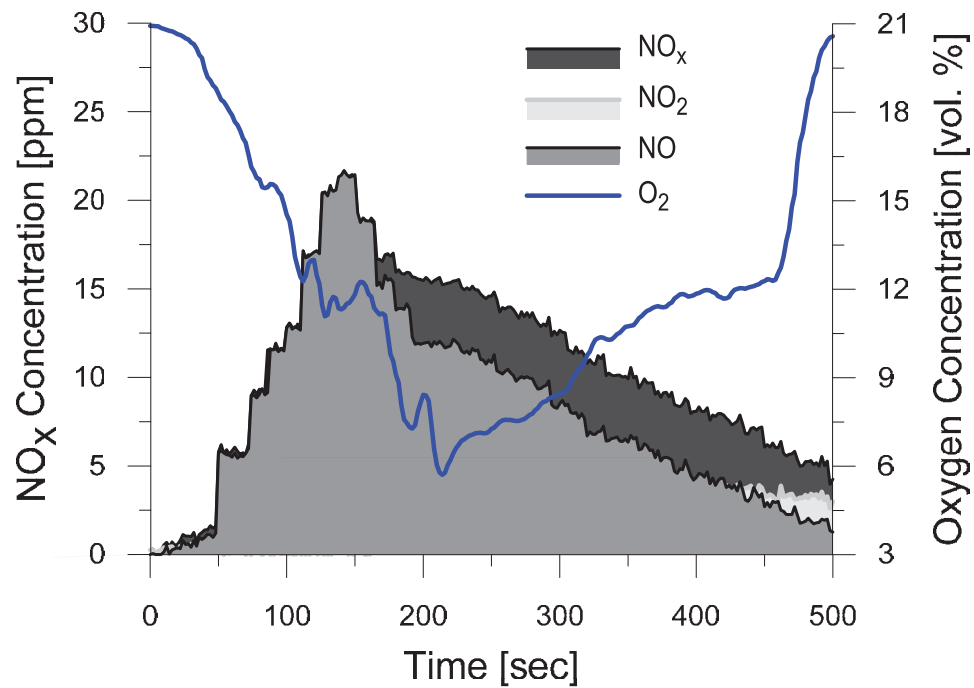
Figure 4-2: NO_x concentrations during a diesel fire characterization burn with door initially open then closed after development of hot layer

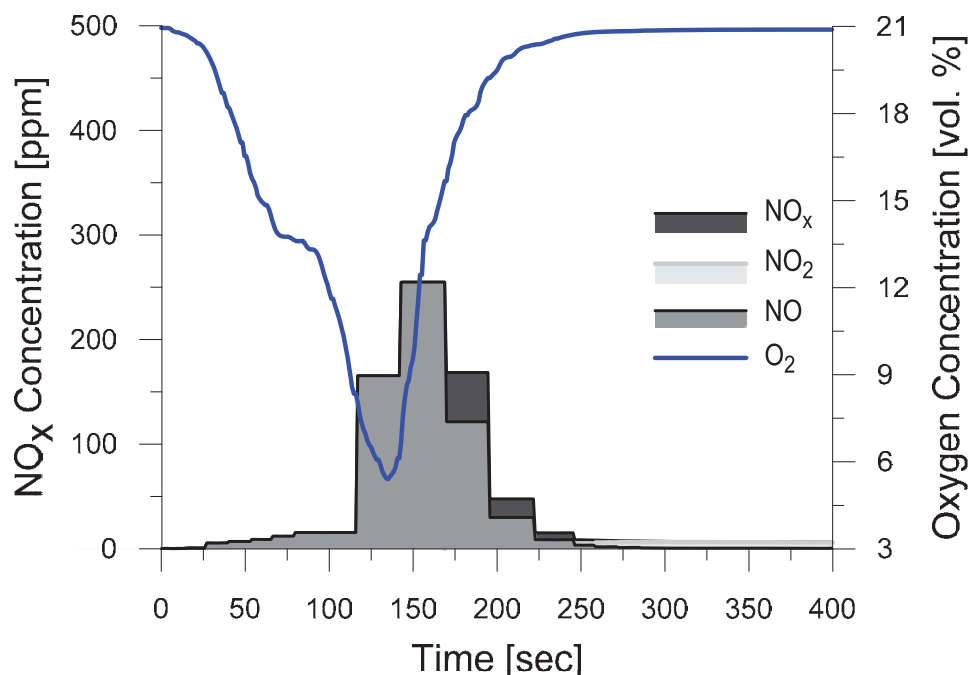
Figure 4-3: Measured NO_x concentrations during diesel burn, Stat X suppression, door open

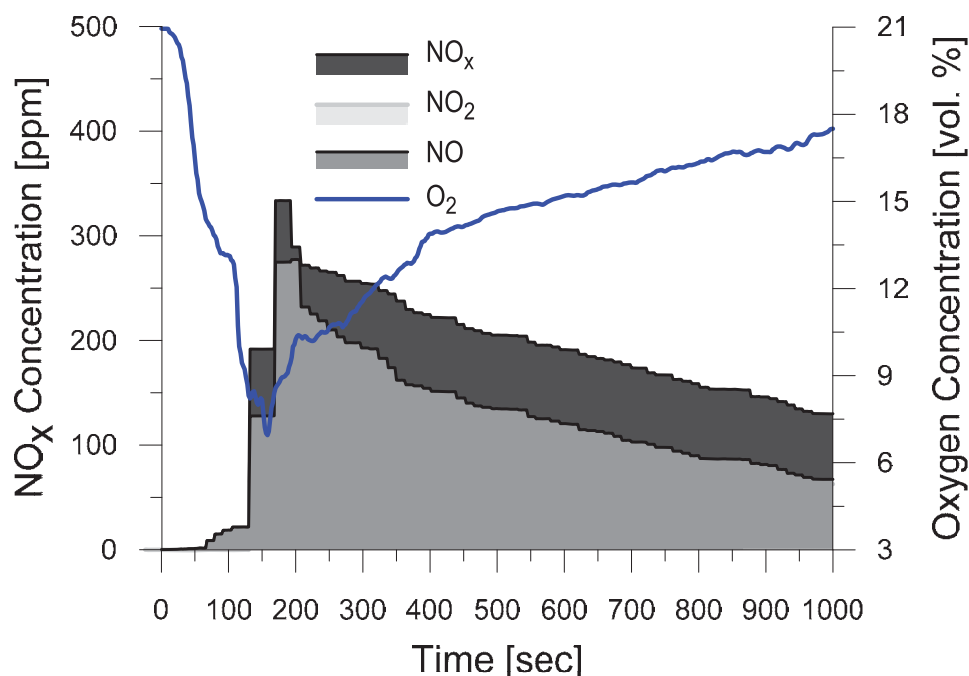
Figure 4-4: Measured NO_x concentrations during diesel burn, Stat X suppression, door closed

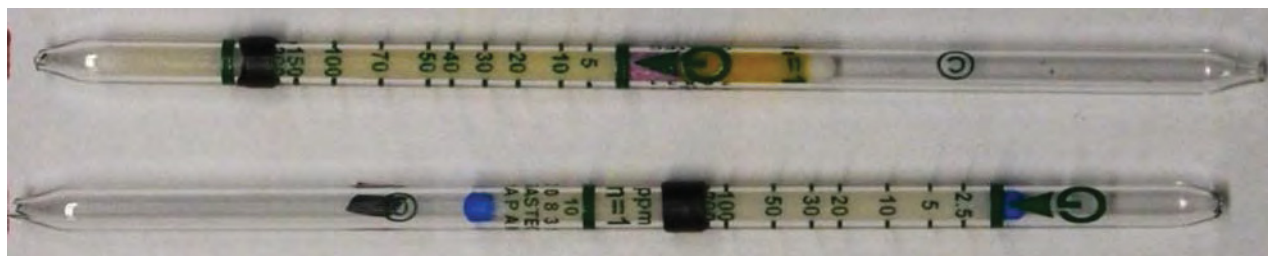
Figure 4-5: NO and NO₂ concentrations measured using Gastec tubes during suppression of a diesel fire using a StatX aerosol (284 seconds)^{2,3}

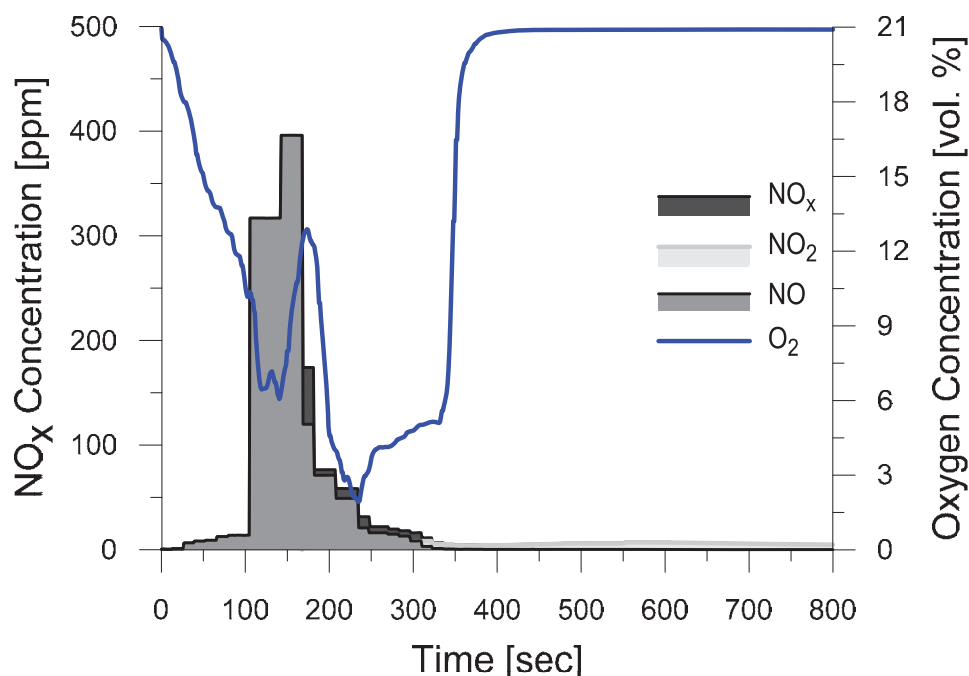
Figure 4-8: Measured NO_x concentrations during diesel burn using DSPA suppression, door open 0.3m

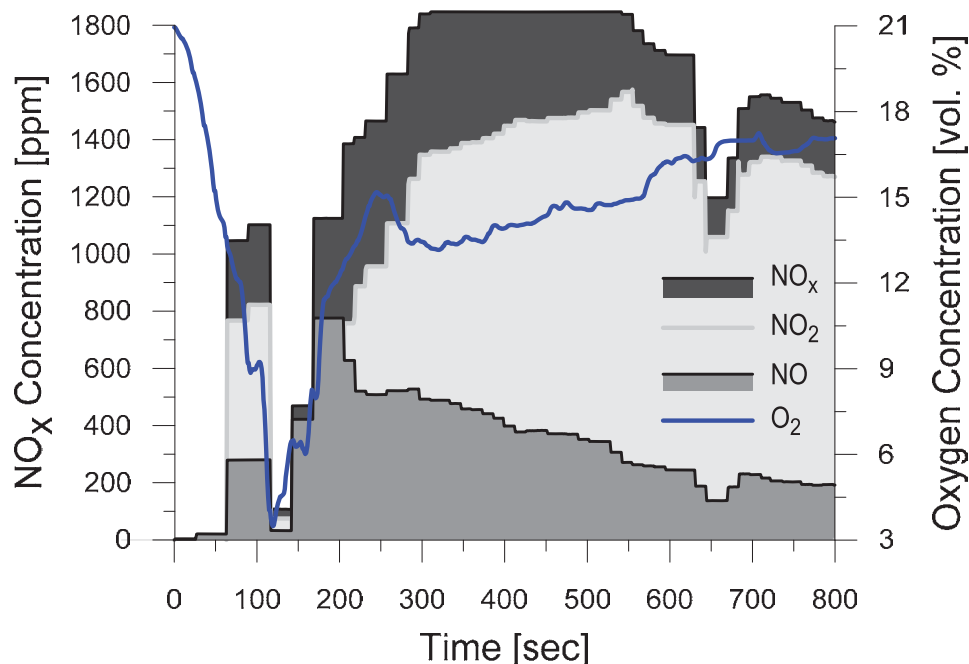
Figure 4-9: Measured NO_x concentrations during diesel burn using DSPA suppression, door closed

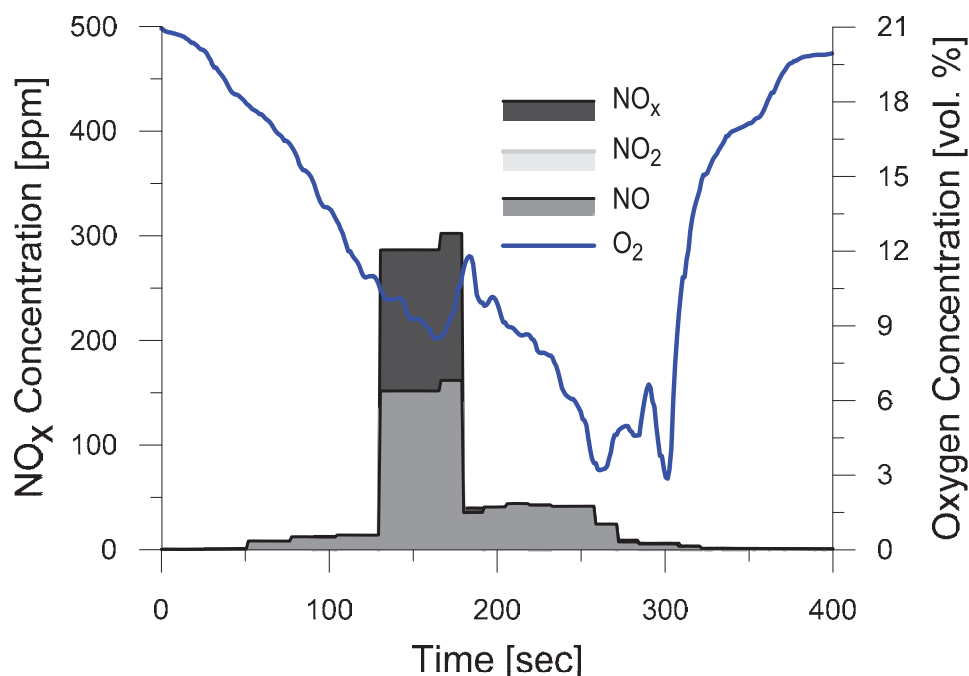
Figure 4-11: Measured NO_x concentrations during an obstructed diesel burn using Stat X suppression, door open 0.3m

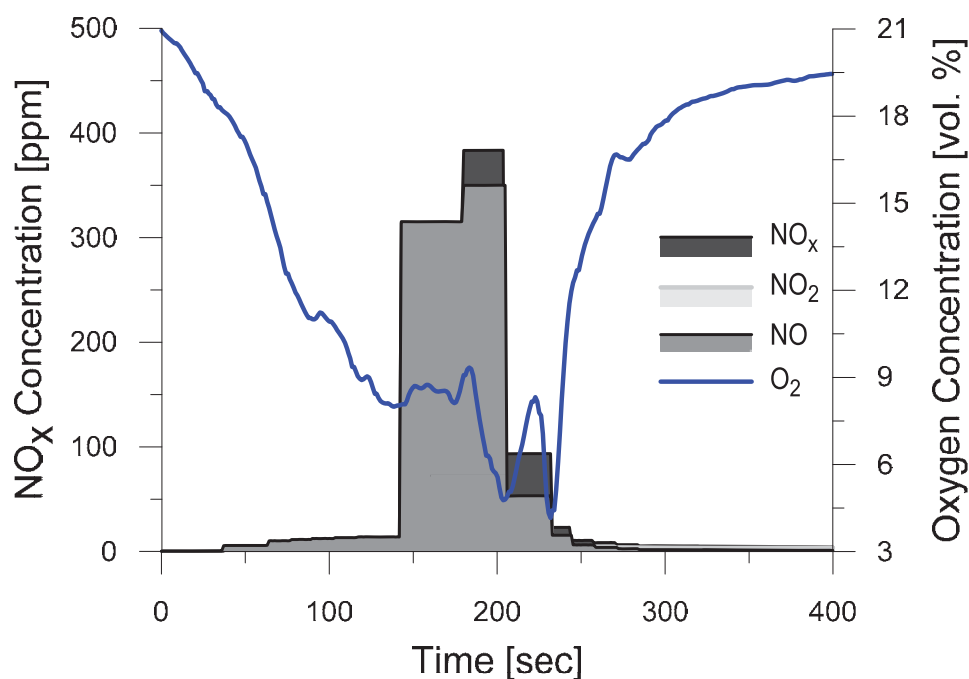
Figure 4-12: Measured NO_x concentrations during an obstructed diesel burn using DSPA suppression, door open 0.3m⁹

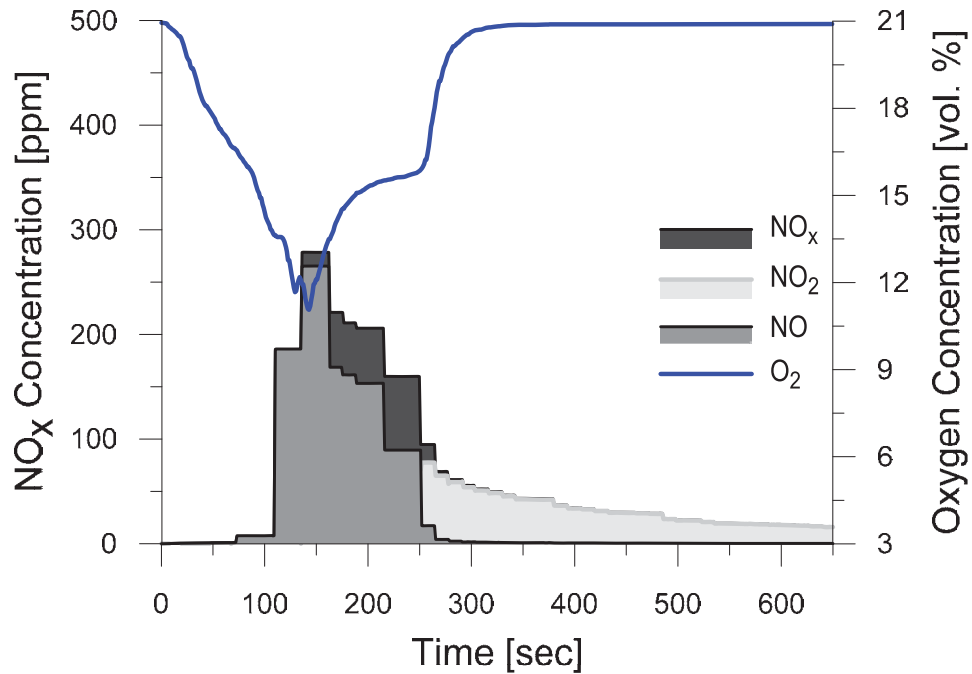
Figure 4-13: Measured NO_x concentrations during an obstructed bilge fire with StatX suppression (door closed at suppression; opened 230 seconds into test)

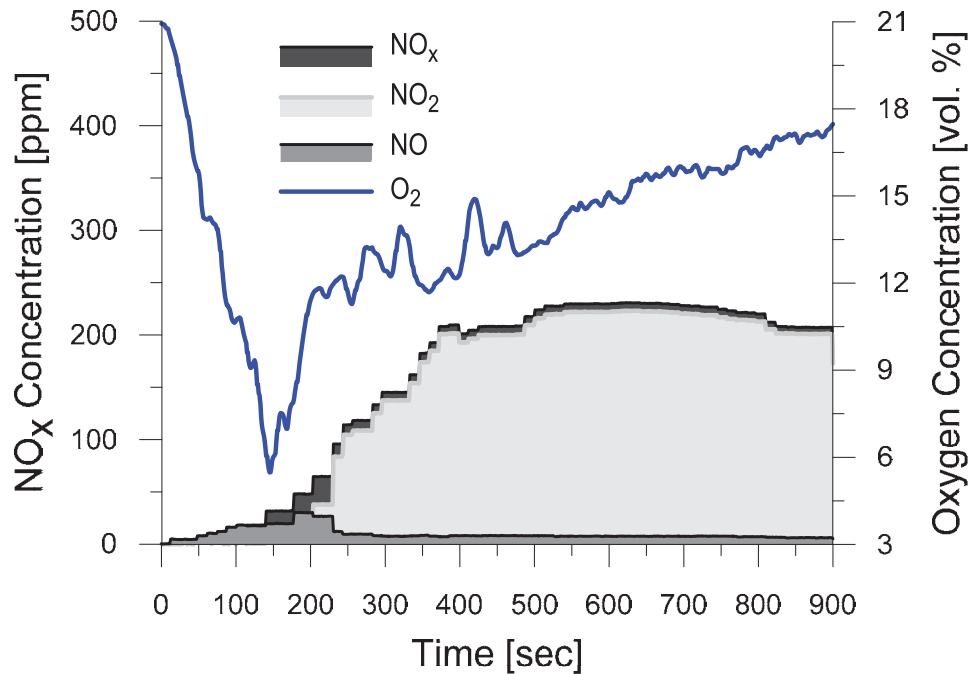
Figure 4-14: Measured NO_x concentrations in an obstructed bilge fire during StatX suppression (door held closed throughout the experiment)

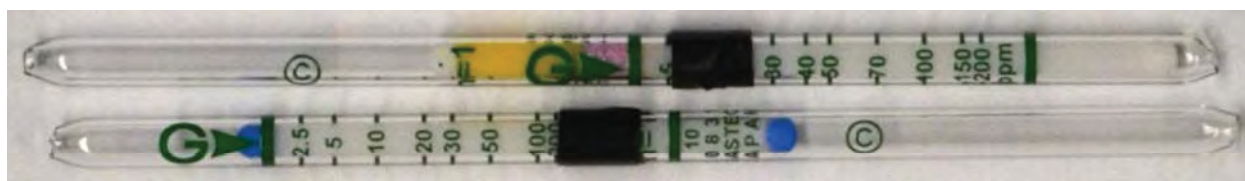
The shifts in concentrations of NO and NO₂ measured using the Novatech system were further confirmed via Gastec samples taken at 770 seconds into the test. As presented in Figure 4-15, Gastec samples indicated concentrations of NO of around 5 ppm (left edge of black tape in upper tube), while that for NO₂ (lower) was much higher, around 200 ppm.

Figure 4-15: NO and NO₂ concentrations measured using Gastec tubes during suppression of an obstructed bilge fire using a StatX aerosol unit (770 seconds)

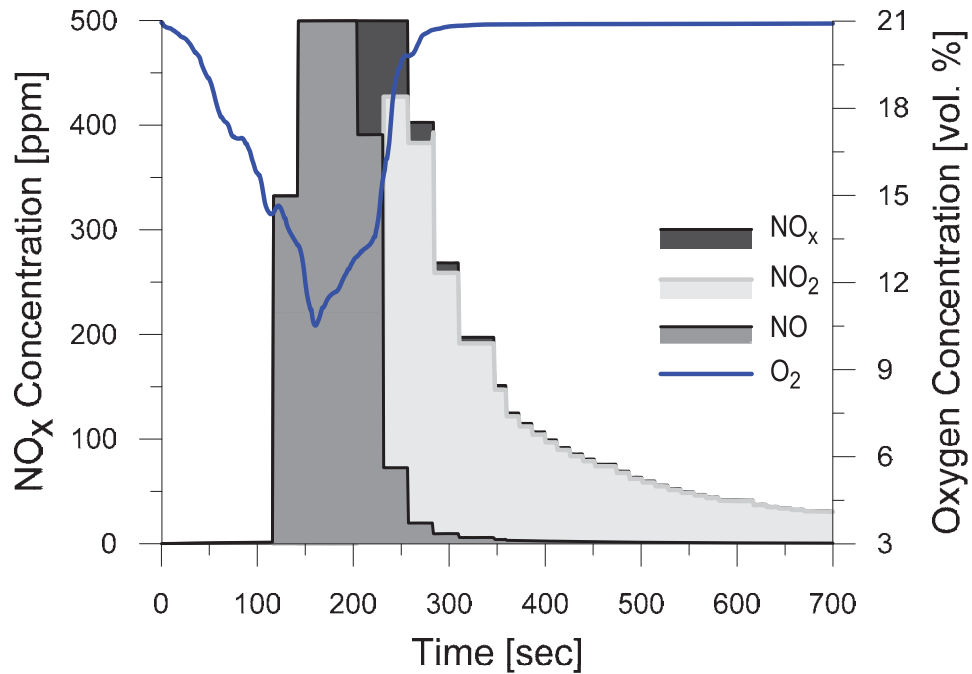
Figure 4-17: Measured NO_x concentrations in an obstructed bilge fire with DSPA 5-4 suppression (door closed at suppression; opened 240 seconds into test)

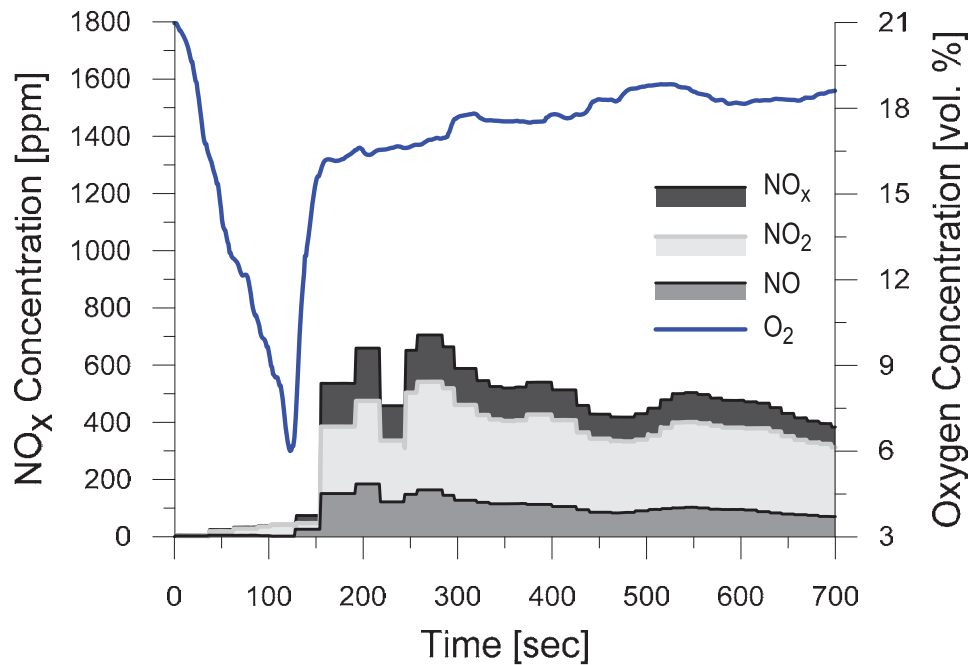
Figure 4-18: Measured NO_x concentrations in an obstructed bilge fire with DSPA 5-4 suppression (door held closed throughout the experiment)

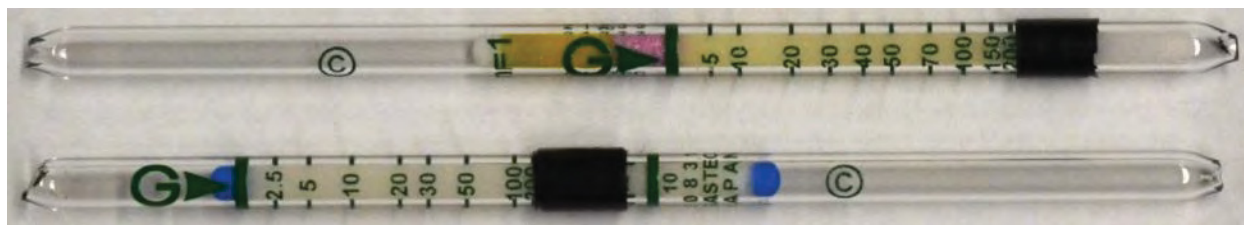
Concentrations of NO and NO₂ measured using the Novatech system were confirmed via Gastec samples taken at 385 seconds into the test and presented in Figure 4-19. Sampling tubes for NO (upper tube) and NO₂ (lower tube) both indicated concentrations at or above 200 ppm.

Figure 4-19: NO and NO₂ concentrations measured using Gastec tubes during suppression of an obstructed bilge fire using DSPA 5-4 aerosol unit (385 seconds)

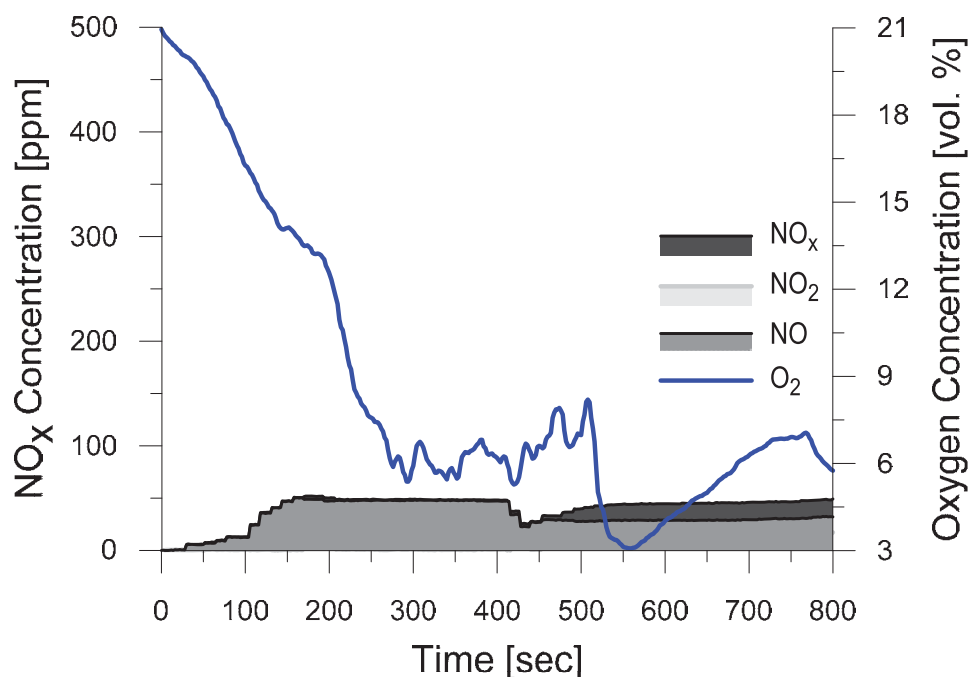
Figure 4-21: Measured NO_x concentrations during a wood crib characterization fire with door initially open then closed after development of hot layer

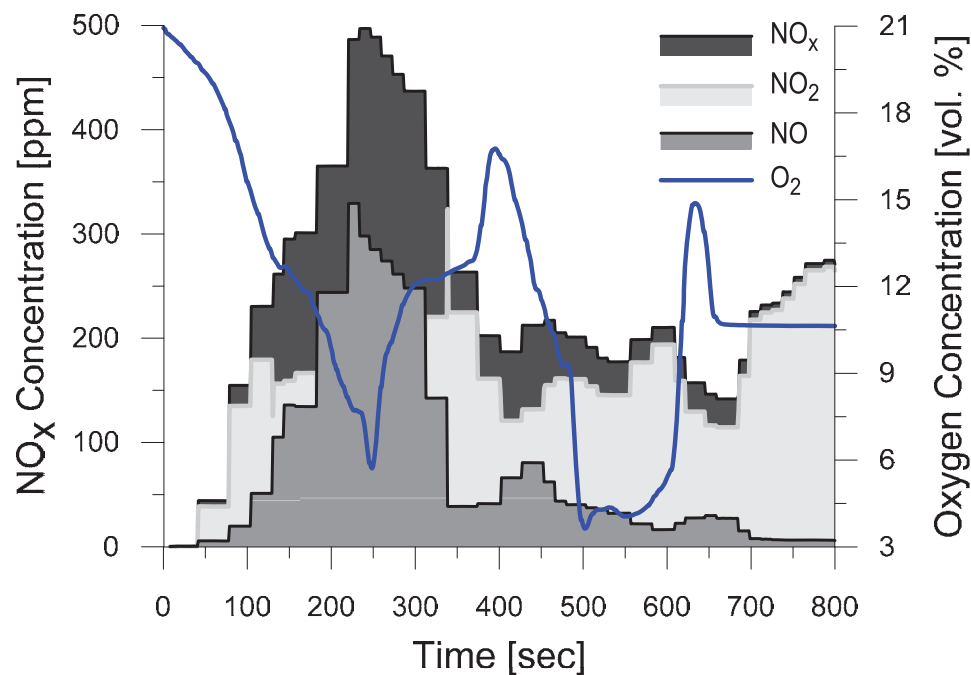
Figure 4-22: Measured NO_x concentrations during softwood crib burn with Stat X suppression (door opened and closed during the experiment)

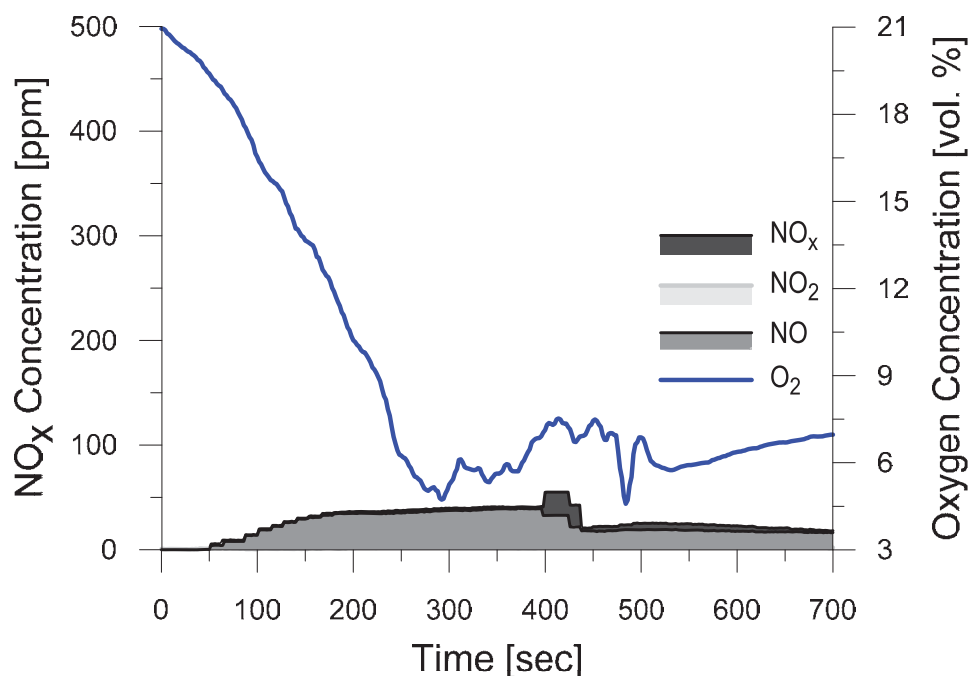
Figure 4-23: Measured NO_x concentrations during softwood crib burn with Stat X suppression (door closed after suppression)

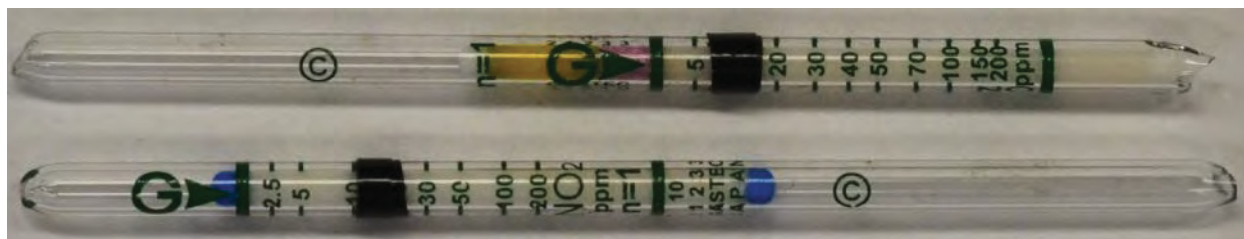
Figure 4-24: NO and NO₂ concentrations measured using Gastec tubes during suppression of a wood crib fire using a Stat X aerosol unit (600 seconds)

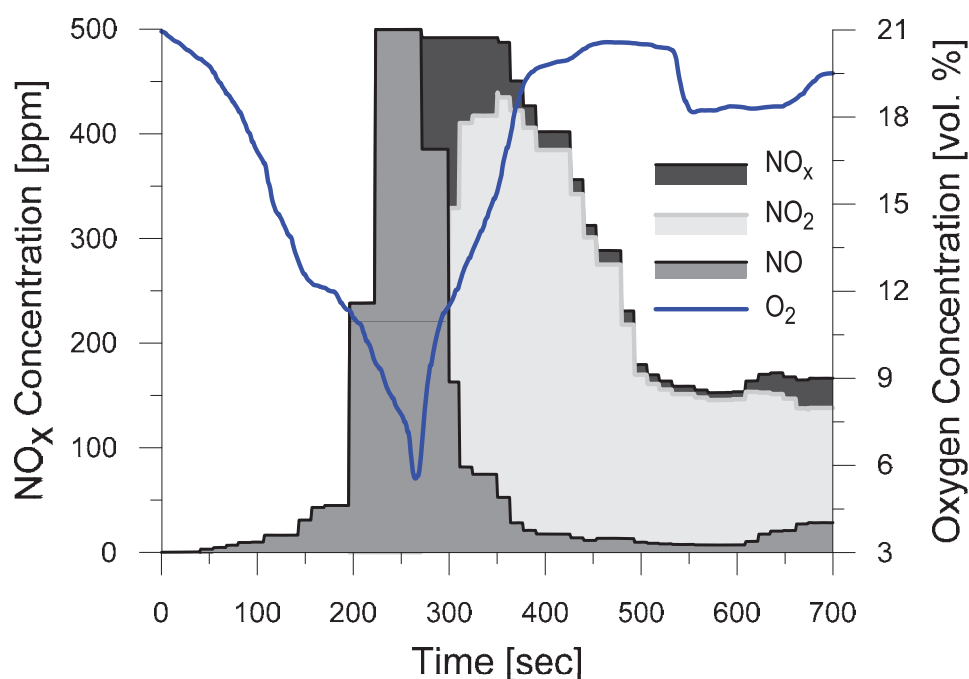
Figure 4-26: Measured NO_x concentrations during a softwood crib fire with suppression by a DSPA 5-4 aerosol unit (door opened and closed during experiment)

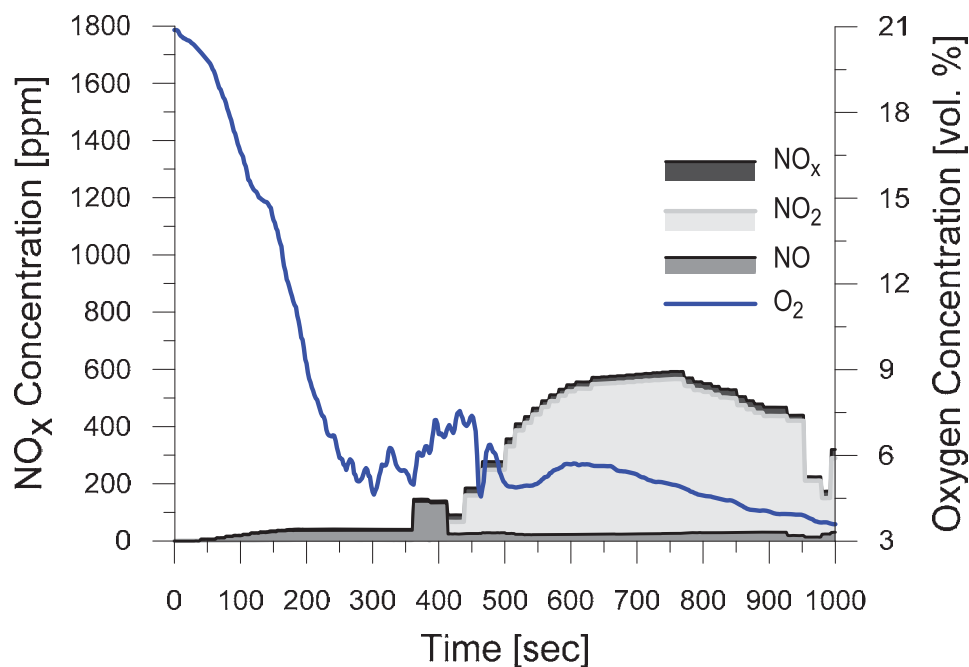
Figure 4-27: Measured NOx concentrations during a softwood crib burn with suppression by a DSPA 5-4 aerosol unit (door closed after suppression)

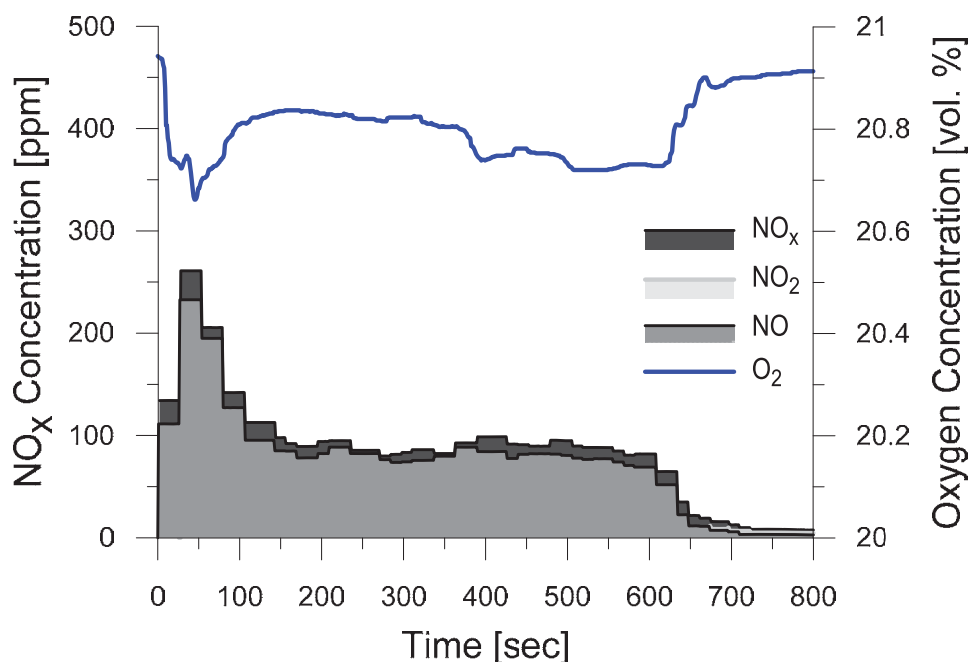
Figure 4-30: NO_x concentrations measured near the outlet of the StatX unit during and after aerosol generation in a cold test compartment with no fire (Test 1)

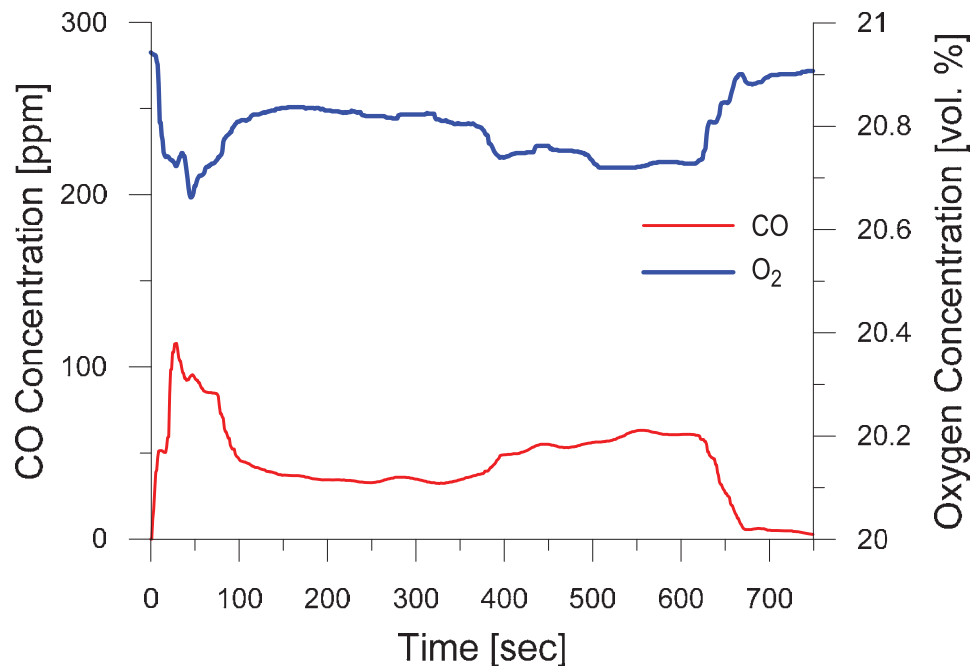
Figure 4-31: CO concentrations measured near the outlet of the StatX unit during and after aerosol generation in a cold test compartment with no fire (Test 1)

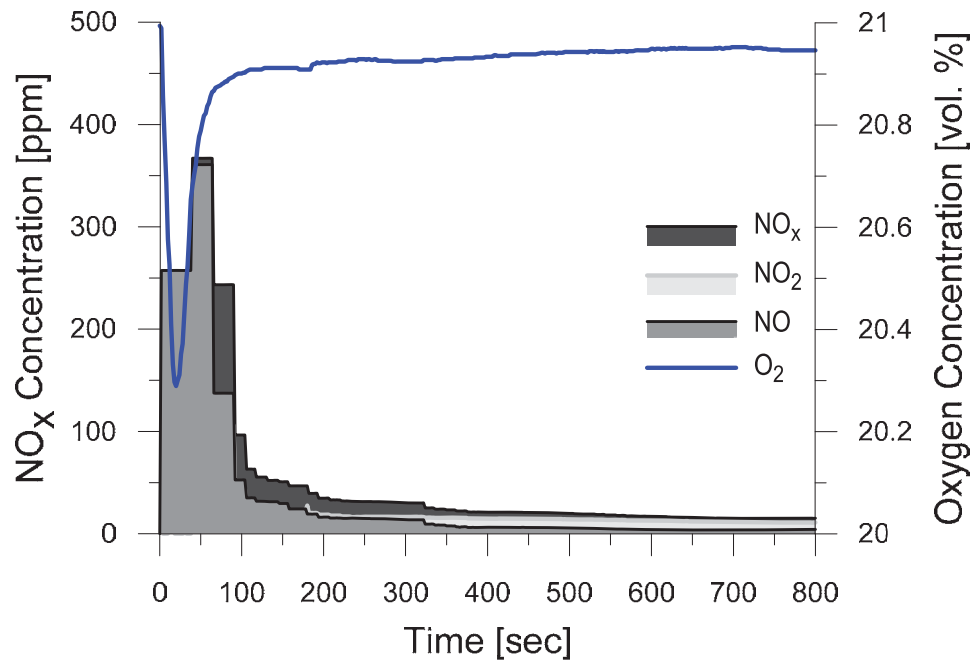
Figure 4-32: Measured NO_x concentrations during and after aerosol generation from a StatX unit into a cold test compartment with no fire (Test 2)

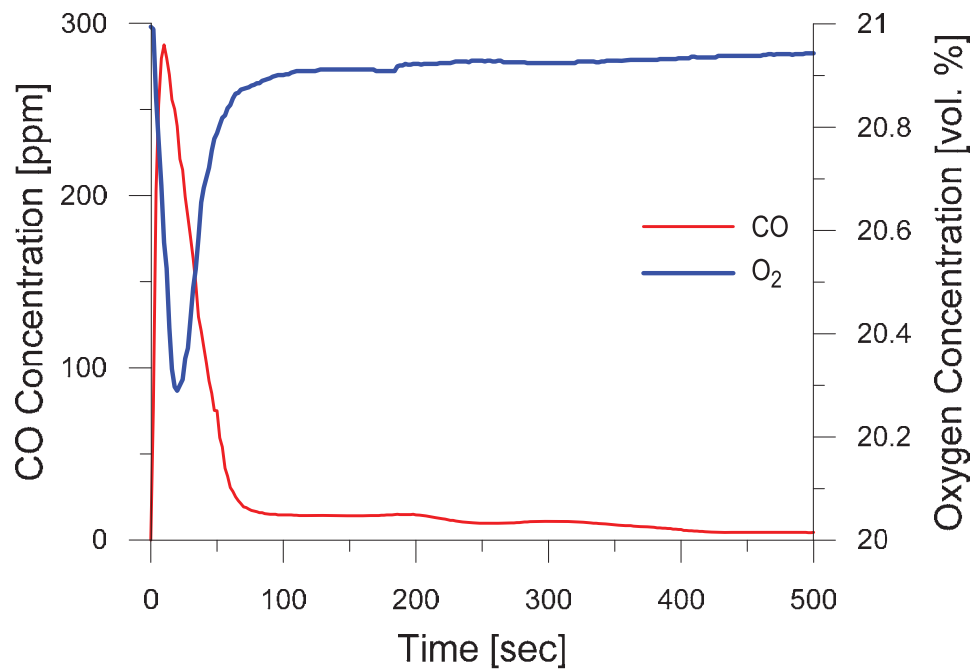
Figure 4-33: Measured CO concentrations during and after aerosol generation from a StatX unit into a cold test compartment with no fire (Test 2)

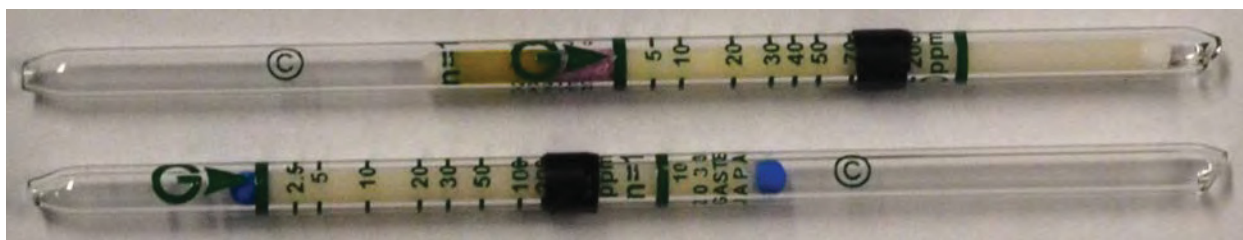
Figure 4-34: NO_x concentrations measured using Gastec sampling tubes during release of Stat X aerosol unit in a test compartment with no fire (Test 2, 100 seconds)

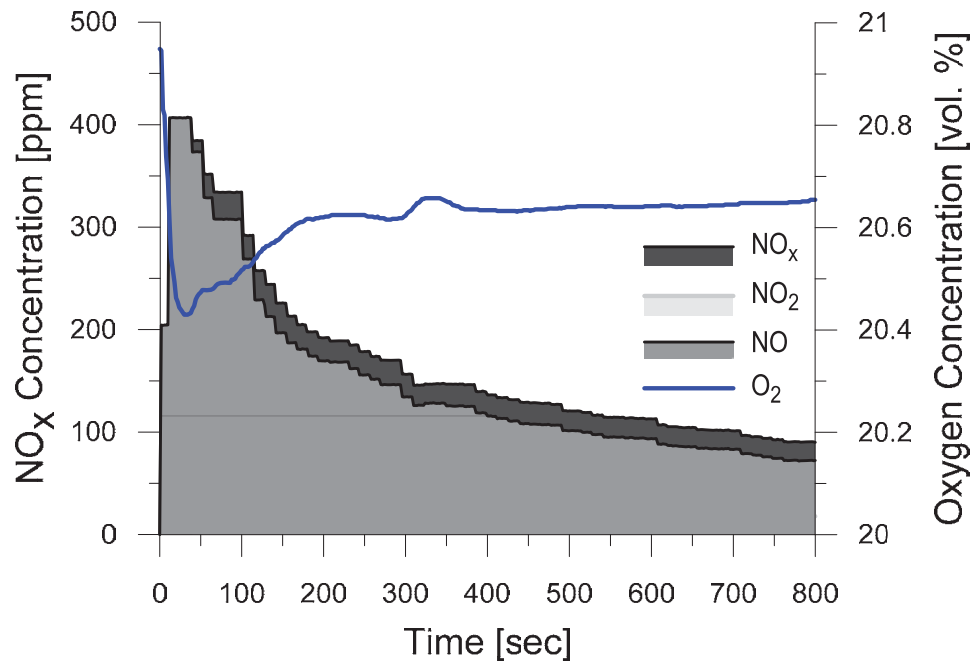
Figure 4-36: Measured NOx concentrations during release of StatX unit into a cold test compartment with no fire (Test 3)

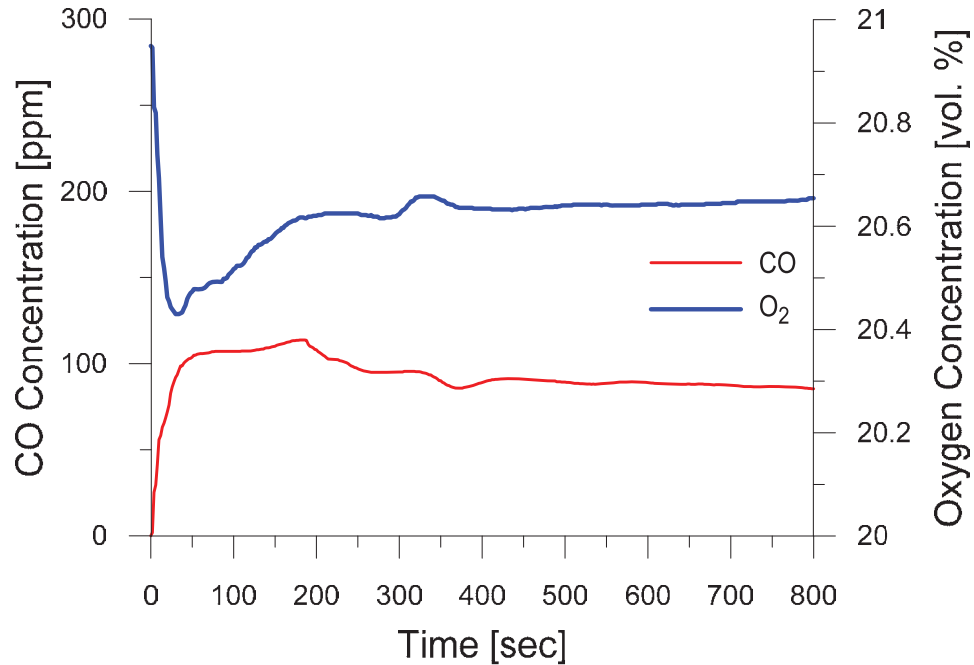
Figure 4-37: Measured CO concentrations during release of a StatX unit into a cold test compartment with no fire (Test 3)

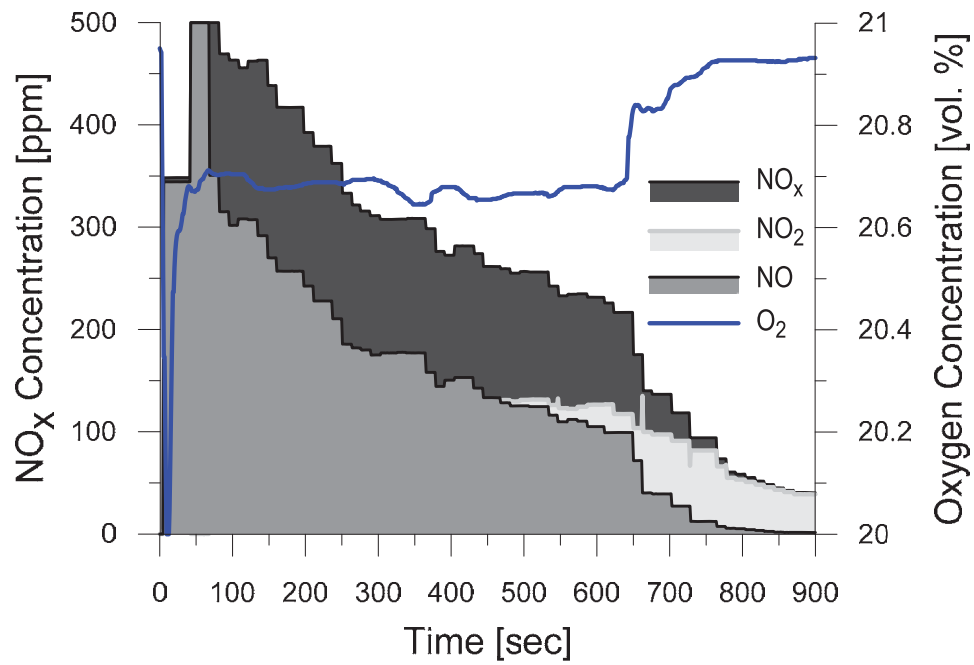
Figure 4-40: Measured NO_x concentrations during release of DSPA unit into a cold test compartment with no fire (Test 1)

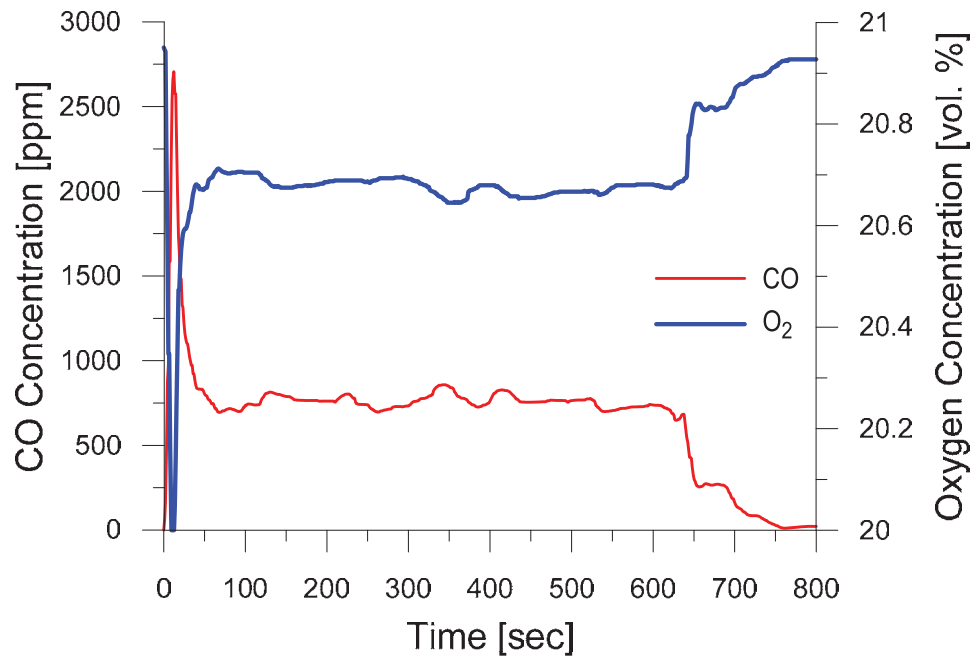
Figure 4-41: Measured CO concentrations during release of DSPA unit into a cold test compartment with no fire (Test 1)

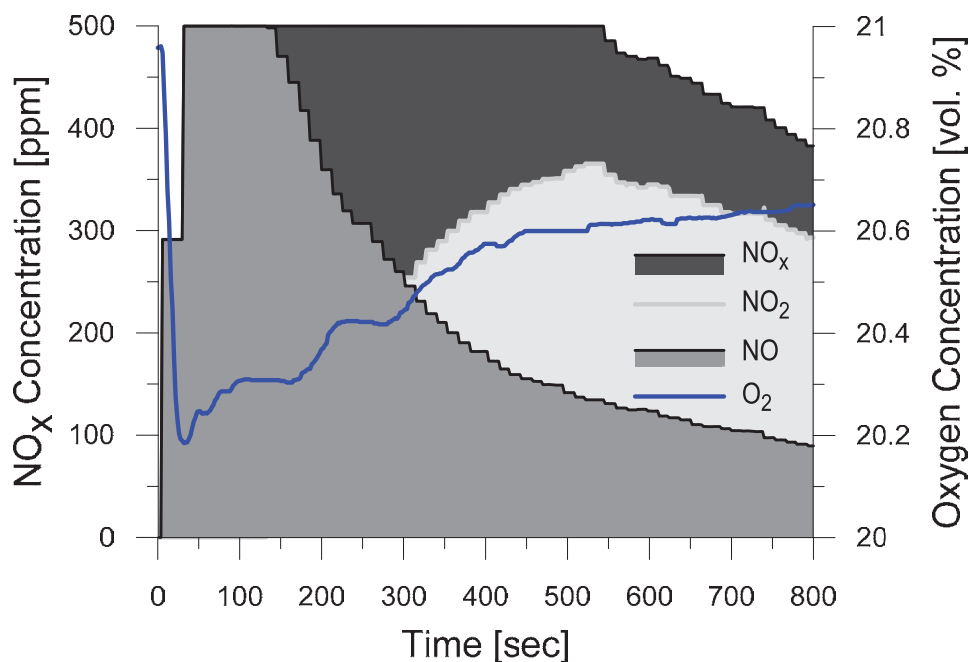
Figure 4-42: Measured NO_x concentrations during release of DSPA unit into a cold test compartment with no fire (Test 2)
